**SITE ASSESSMENT REPORT  
FOR  
WINDHAM ALLOYS SITE  
WINDHAM, PORTAGE COUNTY, OHIO  
TDD: S05-9908-004  
PAN: 9G0401SIXX  
DOCUMENT CONTROL NUMBER: START-05-23-050**

**October 20, 1999**

**UNITED STATES ENVIRONMENTAL PROTECTION AGENCY  
Emergency Response Branch  
77 West Jackson Boulevard  
Chicago, Illinois 60604**

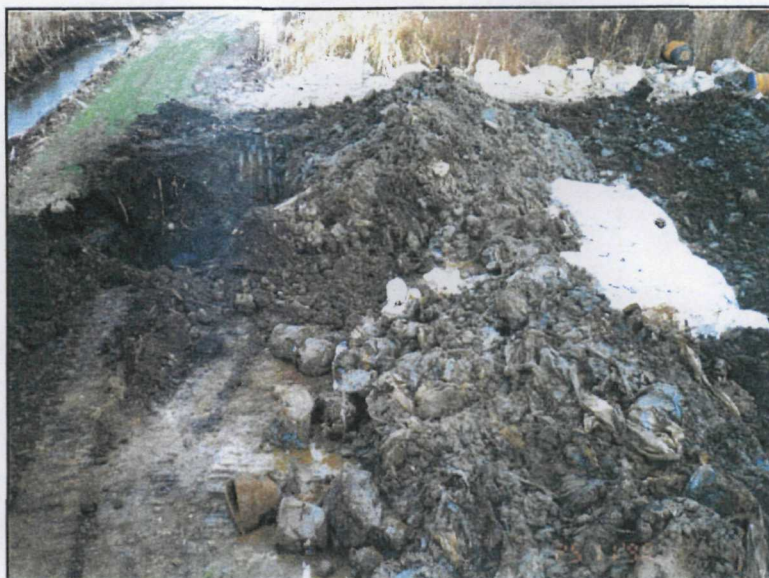
**Site:** Windham Alloys    **TDD:** S05-9908-004    **PAN:** 9G0401SIXX    **Photo:** 1  
**Direction:** North    **Date:** 11-25-98    **Photographer:** Ohio EPA  
**Description:** View of waste materials excavated by Ohio EPA during exploratory test trenching and investigation activities.

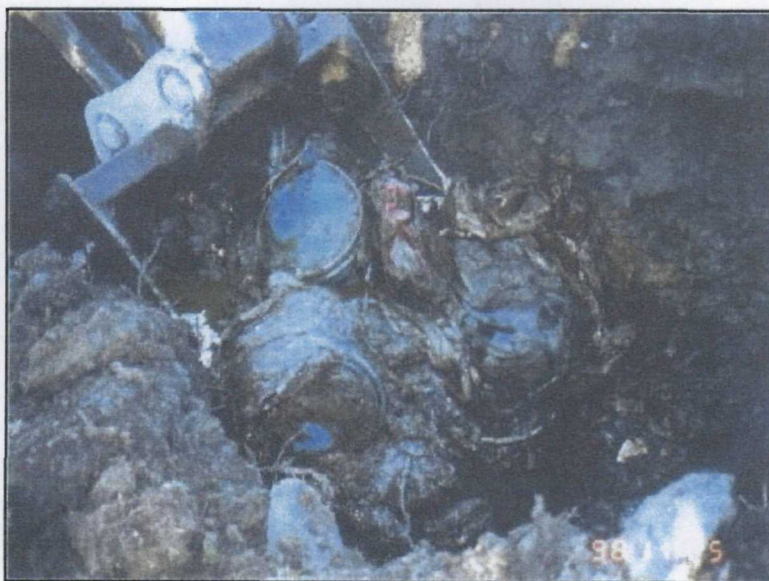
**Site:** Windham Alloys    **TDD:** S05-9908-004    **PAN:** 9G0401SIXX    **Photo:** 2  
**Direction:** East    **Date:** 11-25-98    **Photographer:** Ohio EPA  
**Description:** View of track hoe excavating buried waste materials at the site during the Ohio EPA site investigation.

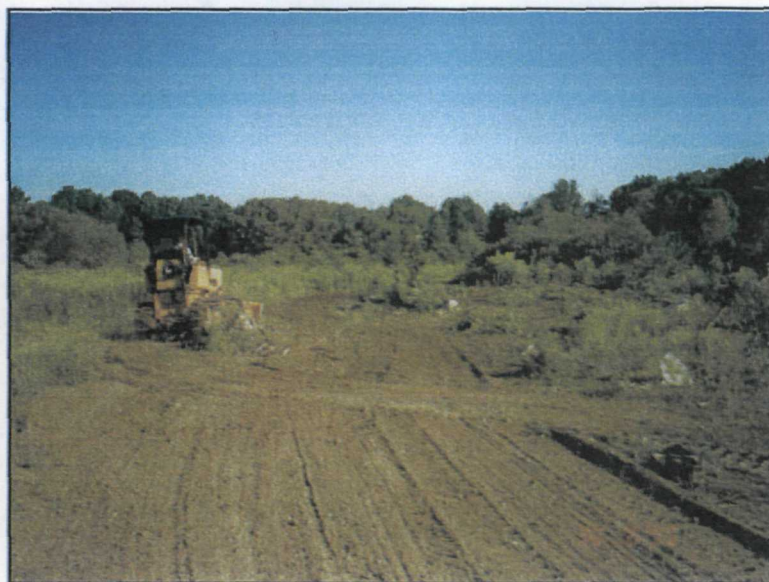
**Site:** Windham Alloys    **TDD:** S05-9908-004    **PAN:** 9G0401SIXX    **Photo:** 3  
**Direction:** North    **Date:** 08-30-99    **Photographer:** W. Balser  
**Description:** View of START subcontractor completing clearing and grubbing activities at the site.

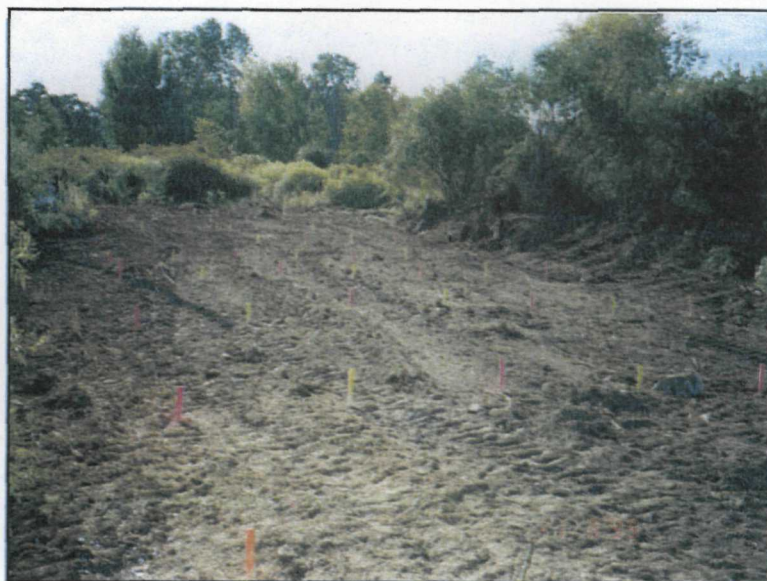
**Site:** Windham Alloys    **TDD:** S05-9908-004    **PAN:** 9G0401SIXX    **Photo:** 4  
**Direction:** East    **Date:** 08-31-99    **Photographer:** W. Balser  
**Description:** View of START grid system located in Area 2.

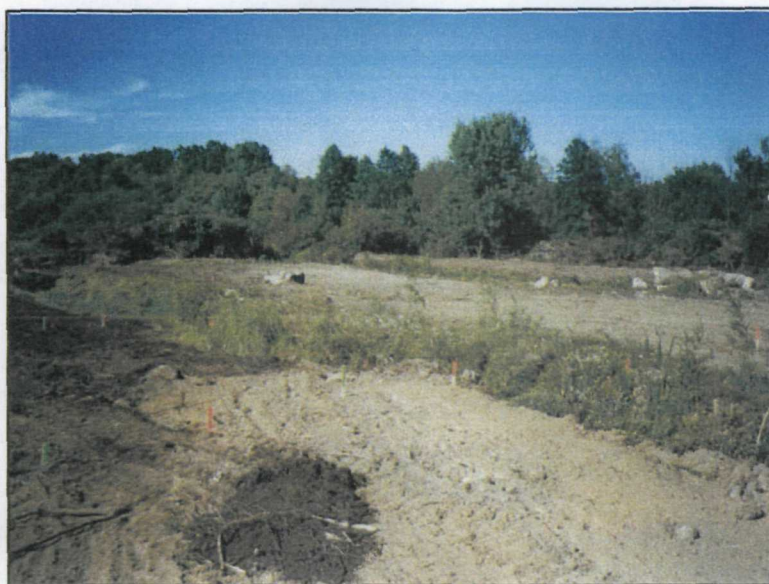
**Site:** Windham Alloys    **TDD:** S05-9908-004    **PAN:** 9G0401SIXX    **Photo:** 5  
**Direction:** Northeast    **Date:** 08-31-99    **Photographer:** W. Balser  
**Description:** Overview of the START grid system located in Area 1 and site ditches shown with vegetation cover.

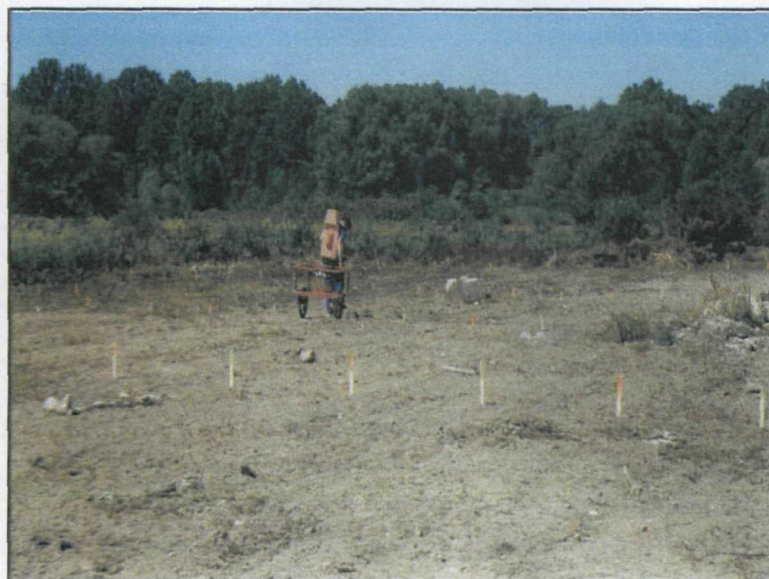
**Site:** Windham Alloys    **TDD:** S05-9908-004    **PAN:** 9G0401SIXX    **Photo:** 6  
**Direction:** Northwest    **Date:** 09-02-99    **Photographer:** W. Balser  
**Description:** View of START conducting a geophysical survey of the site with the EM61 unit.
